**2016 Data Report
for
East White Lake, Muskegon County**

Site ID: 610330

2016 CLMP Results

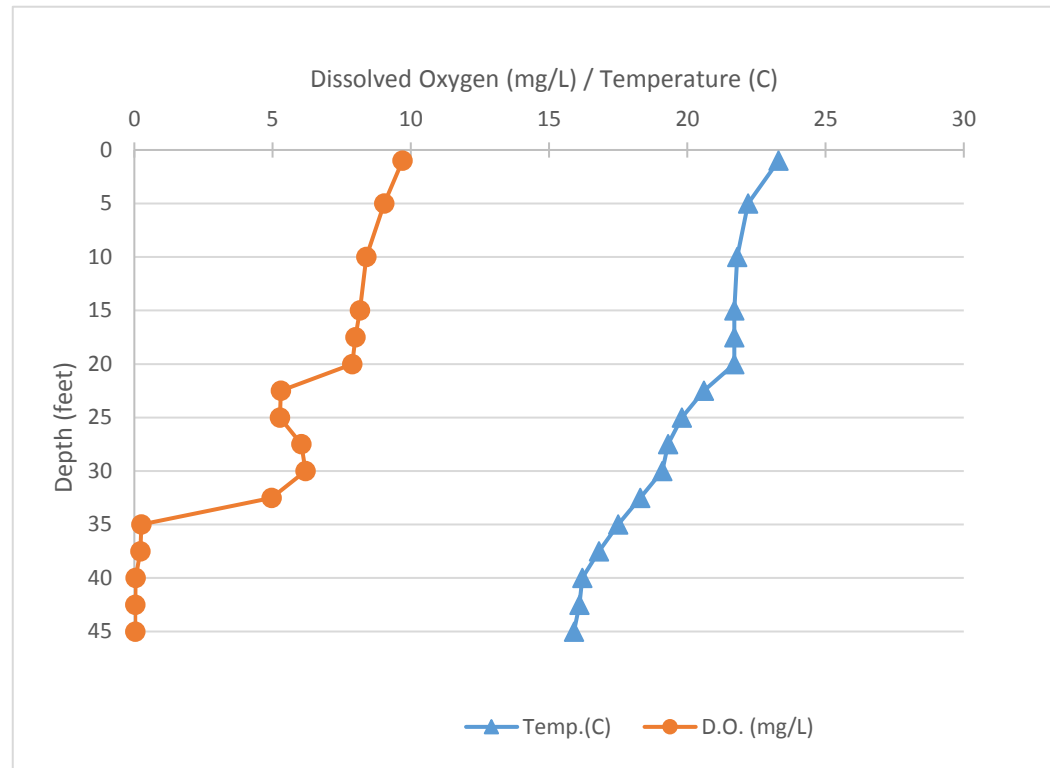
9/16/2016

Dissolved Oxygen and Temperature Profile

Depth (ft)	Temp.(C)	D.O. (mg/L)
1	23.3	9.7
5	22.2	9.04
10	21.8	8.39
15	21.7	8.16
17.5	21.7	8
20	21.7	7.88
22.5	20.6	5.3
25	19.8	5.26
27.5	19.3	6.04
30	19.1	6.19
32.5	18.3	4.96
35	17.5	0.25
37.5	16.8	0.22
40	16.2	0.05
42.5	16.1	0.04
45	15.9	0.03

With an average TSI score of 47 based on chlorophyll-a and summer total phosphorus, this lake is rated between the mesotrophic and eutrophic lake classification. The lake leans slightly more meso than eutro. The lake keeps some dissolved oxygen in the bottom waters through early summer, but by mid-summer the bottom water is devoid of oxygen. Long term trends indicate that the trophic status parameters have not changed beyond minor year-to-year variation since monitoring began in 1989.
